Dollar Community Council – Road Hazard Awareness Campaign
April 8th, 2022.

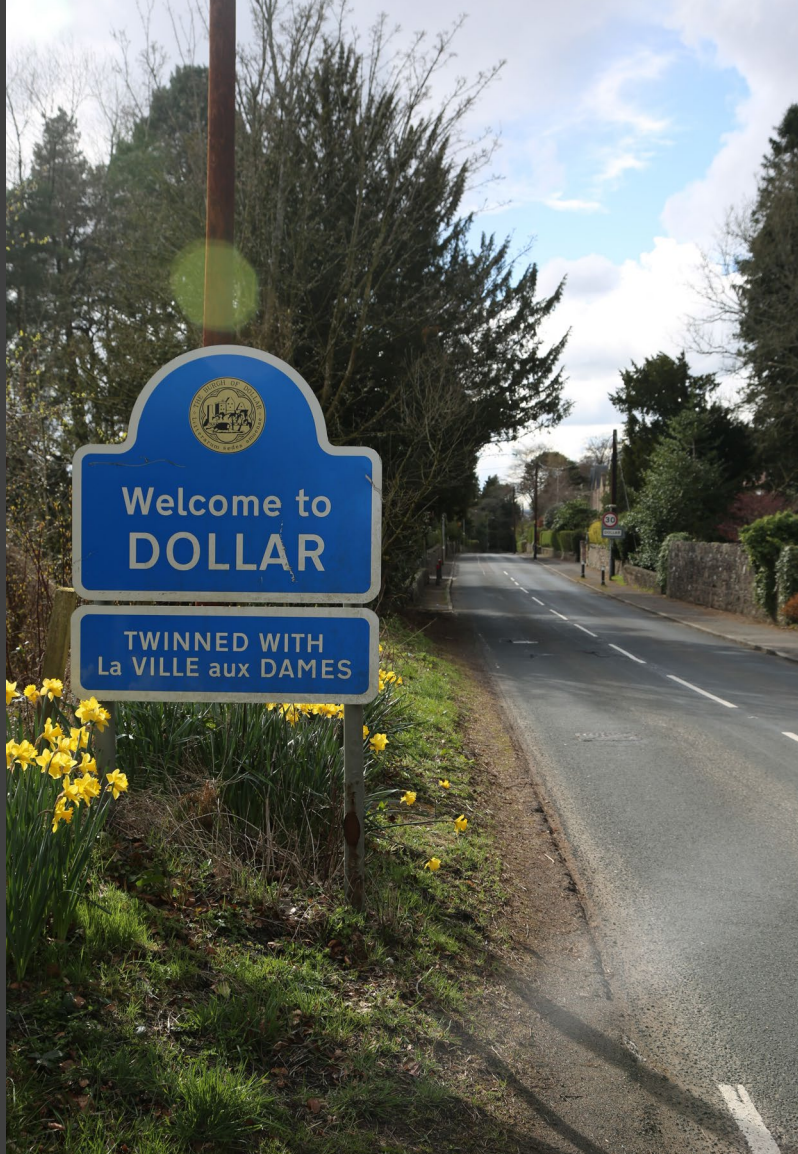
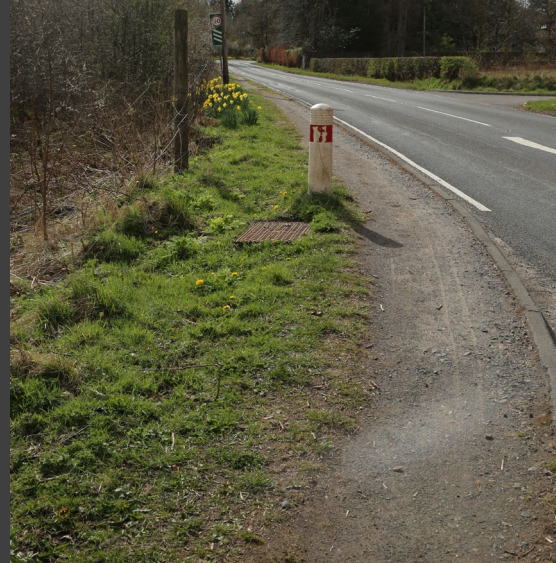
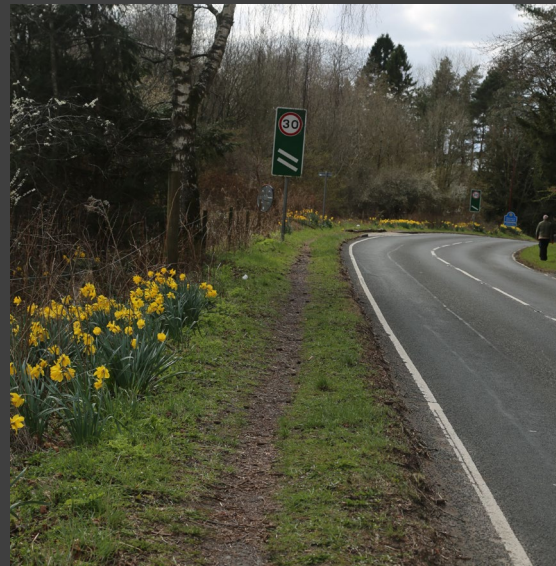
The path on the South side of the A91 approaching Dollar from Muckhart looks initially good: wide enough for pedestrians to use in safety away from passing traffic.

Gradually the path fades away to unusable on the very edge of the 60mph limit making it dangerous for pedestrians and road users, unpassable by pedestrians with pushchairs and it is un navigable for those in a wheelchair.

This is despite connecting to a clearly signposted "Path" that loops round the south of the town and is a popular family walking area.

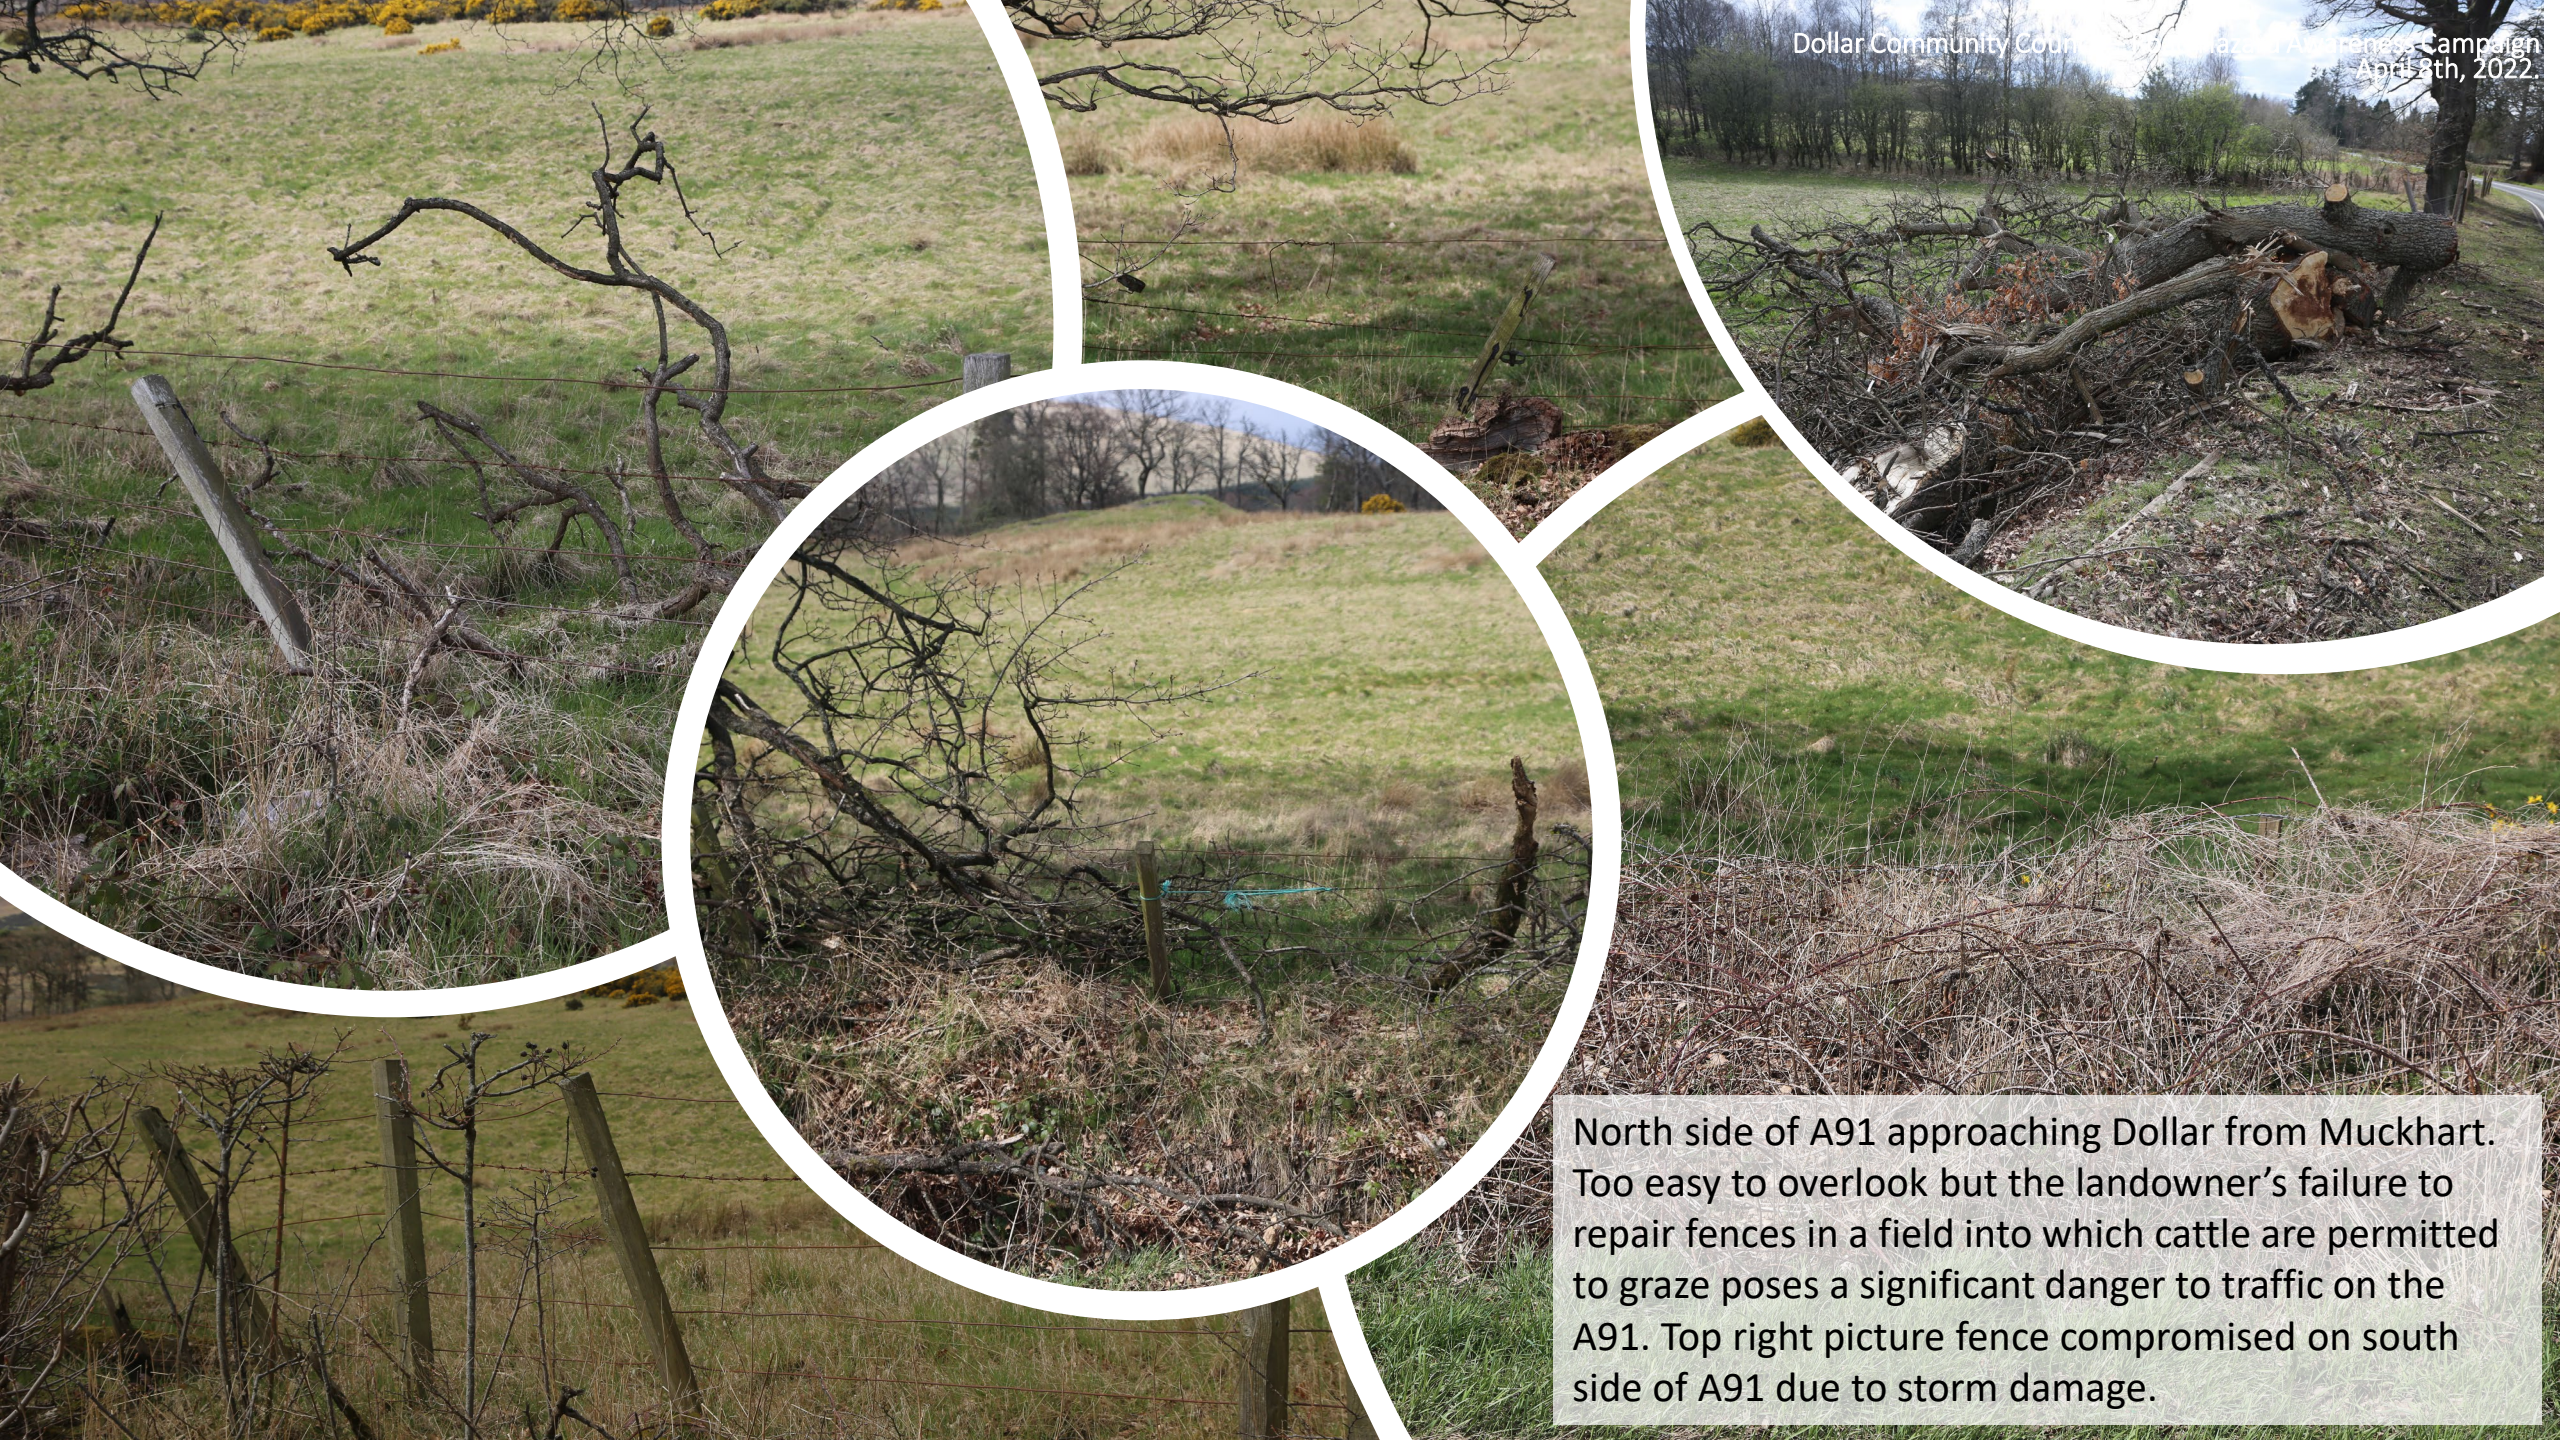
North side of A91 approaching Dollar from Muckhart. Too easy to overlook but the landowner's failure to repair fences in a field into which cattle are permitted to graze poses a significant danger to traffic on the A91. Top right picture fence compromised on south side of A91 due to storm damage.

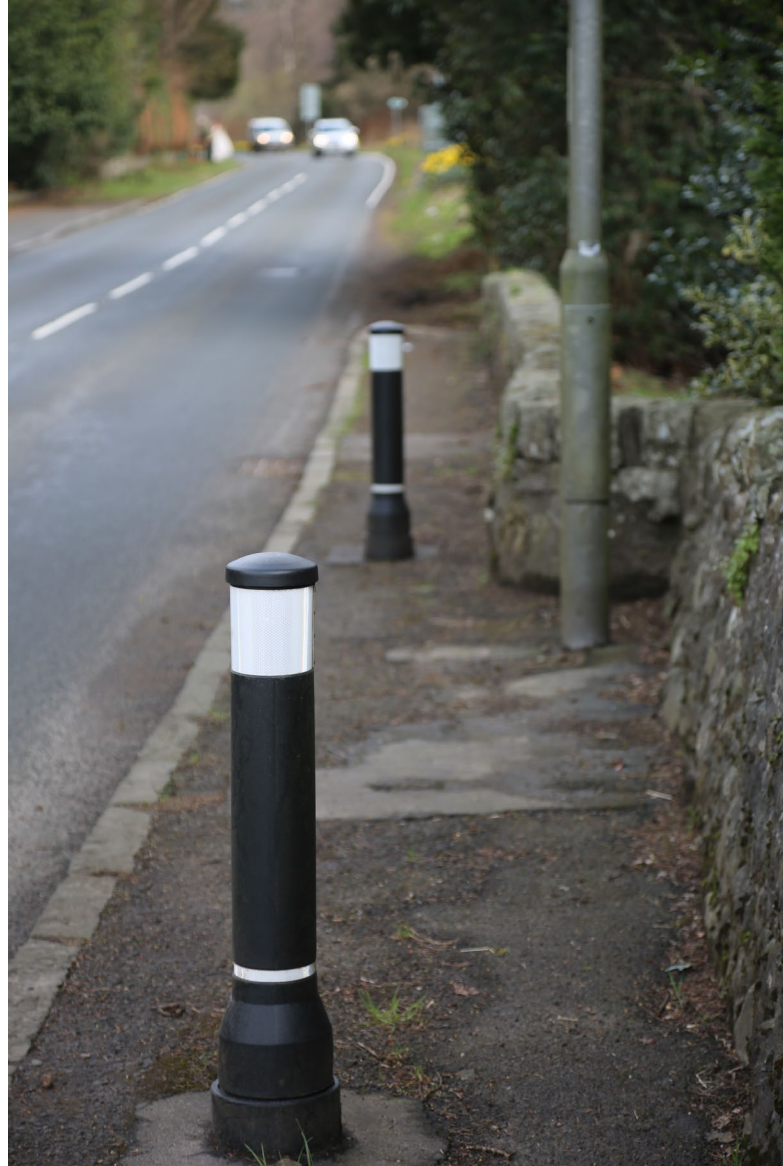
South side of Bridge Street approaching Dollar from Muckhart.

This safety hazard is an example of a good idea badly executed.

Yes it gives notice to road users of the hazard of the wall and the pathway ahead, however the location of the bollards forces pedestrians with pushchairs into the path of oncoming traffic and brings wheelchair bound residents to a complete impasse.

Why are these bollards required and if they are required why position them in the middle of the pathway putting pedestrians in danger of the oncoming traffic?

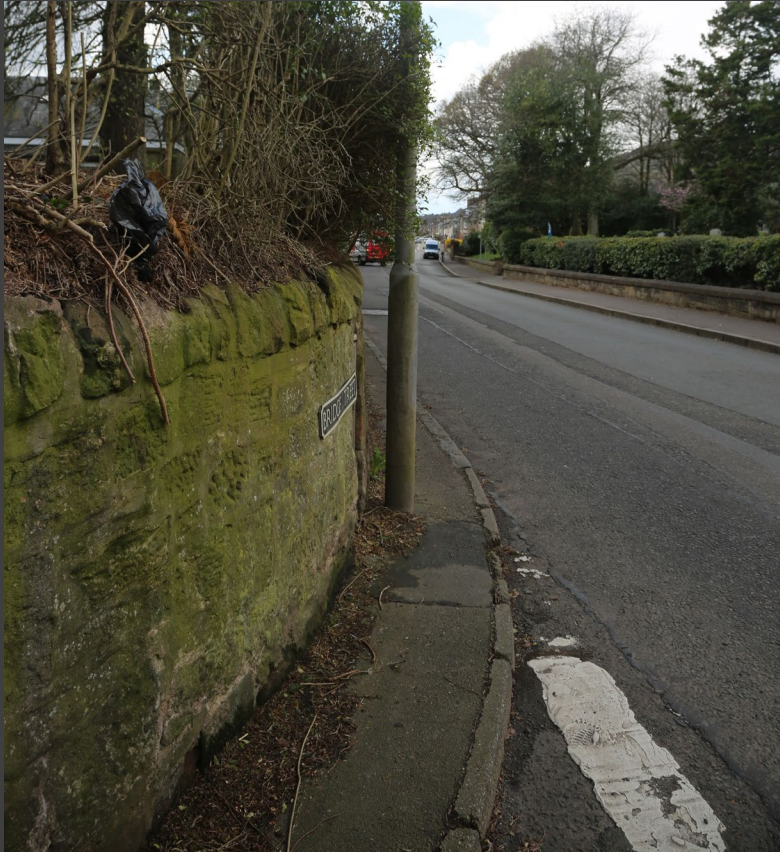
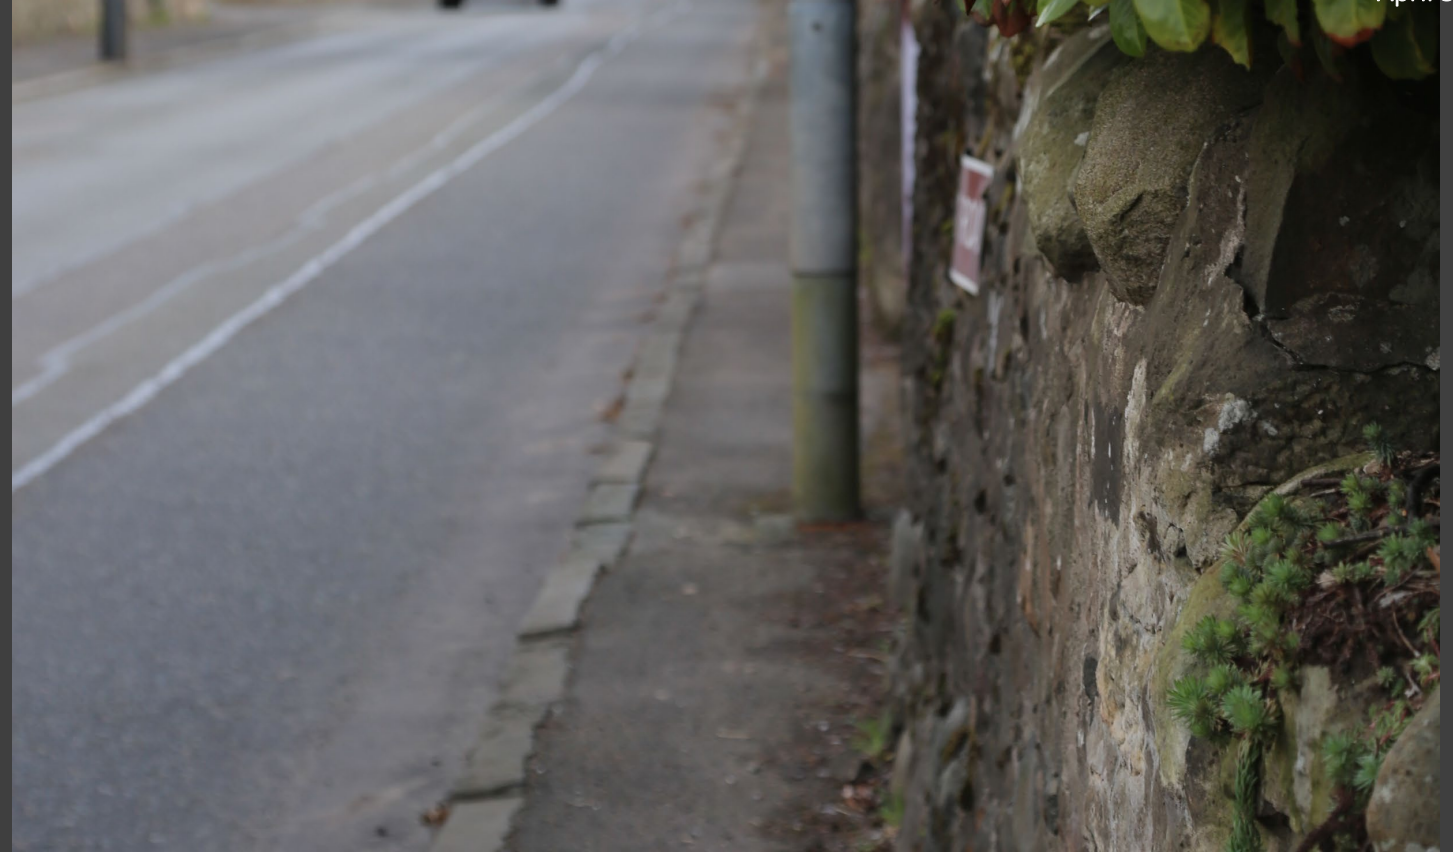
Bridge Street, Dollar. Heading into town along the A91 from Muckhart.

Similar to other concerns, these pictures illustrate the dangerously narrow pathways with lamp-posts forcing pedestrians into the roadway and narrow pathways unprotected from the danger of road traffic.

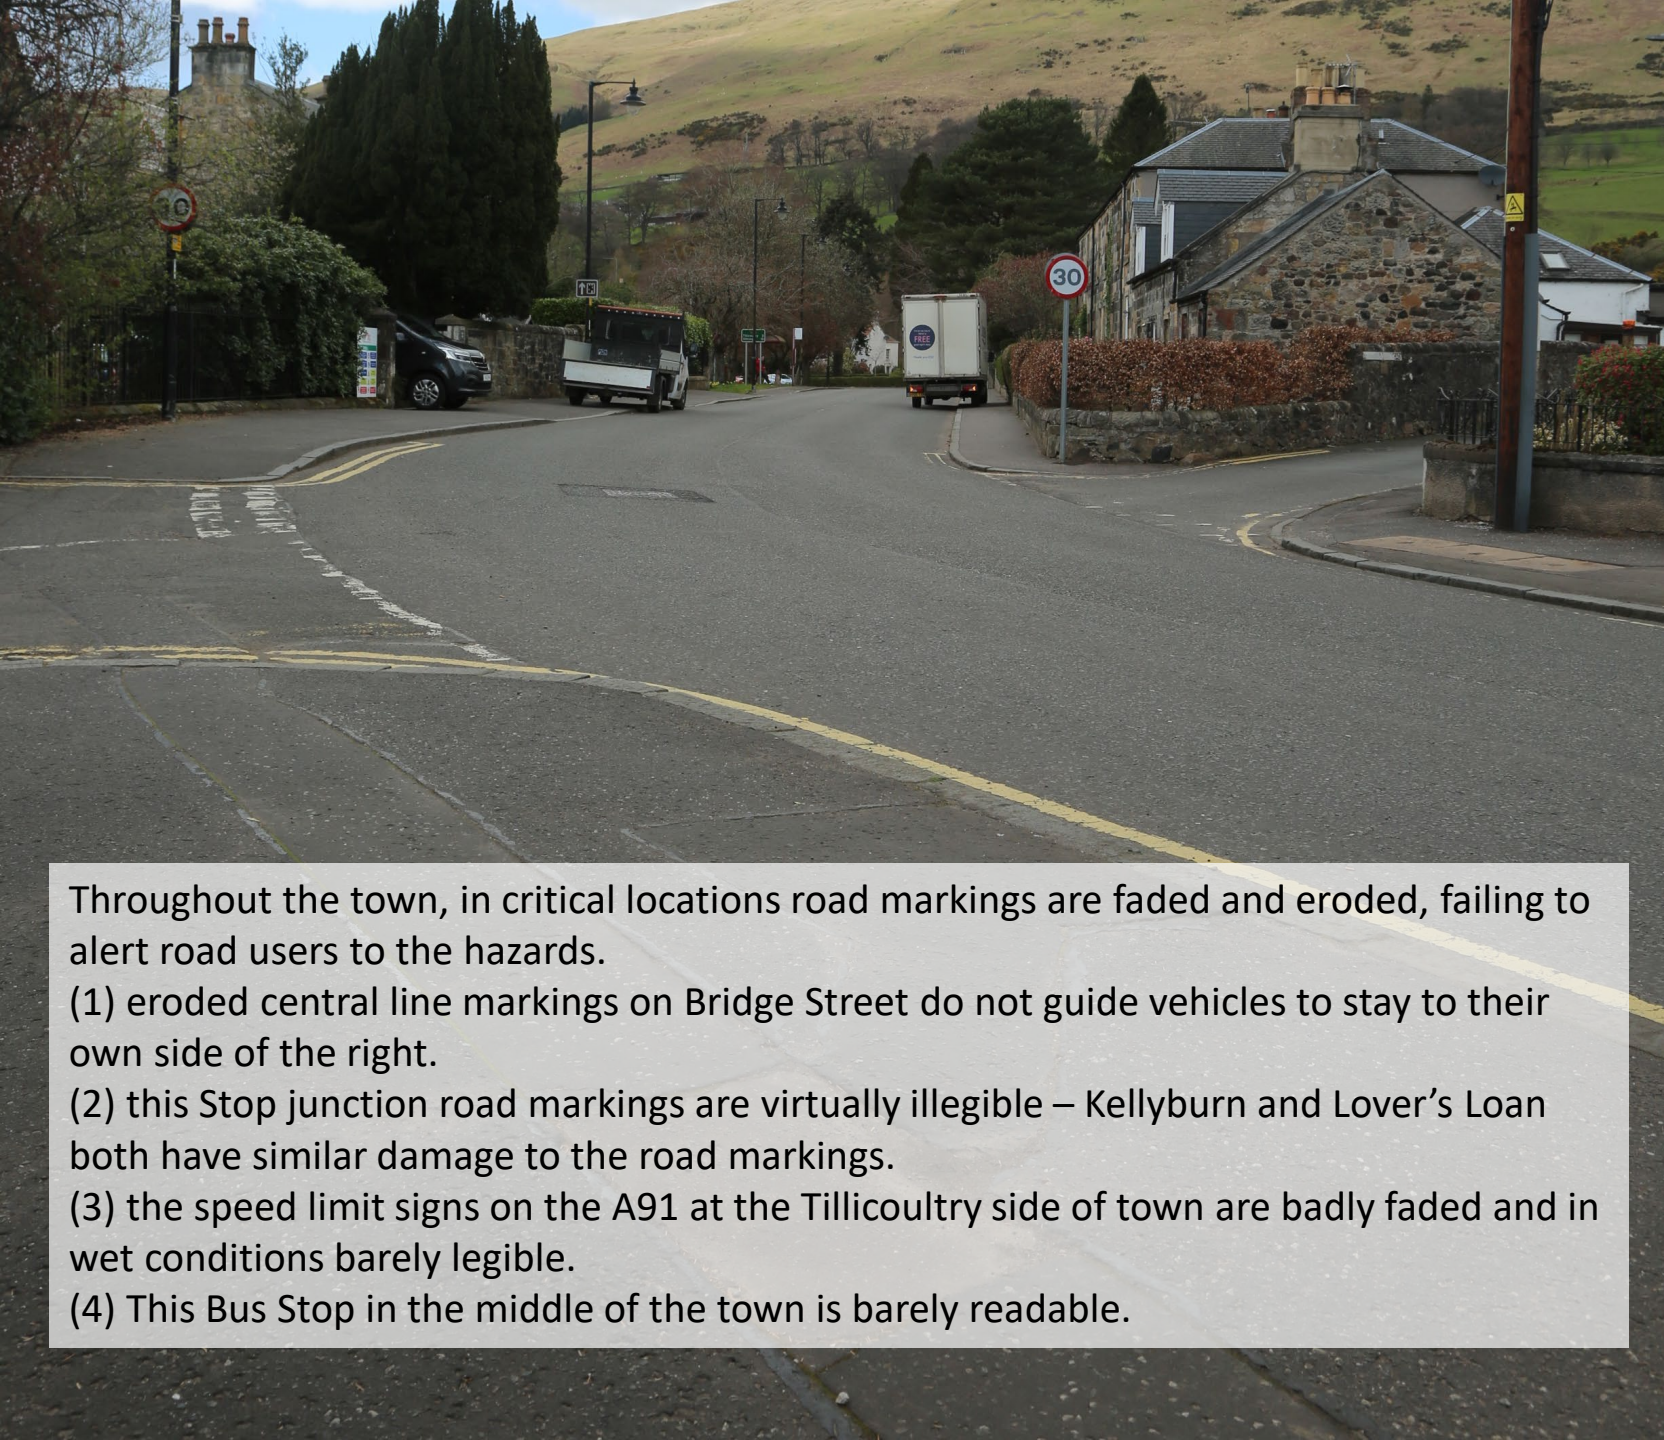
Throughout the town, in critical locations road markings are faded and eroded, failing to alert road users to the hazards.

- (1) eroded central line markings on Bridge Street do not guide vehicles to stay to their own side of the road.
- (2) this Stop junction road markings are virtually illegible – Kellyburn and Lover’s Loan both have similar damage to the road markings.
- (3) the speed limit signs on the A91 at the Tillicoultry side of town are badly faded and in wet conditions barely legible.
- (4) This Bus Stop in the middle of the town is barely readable.

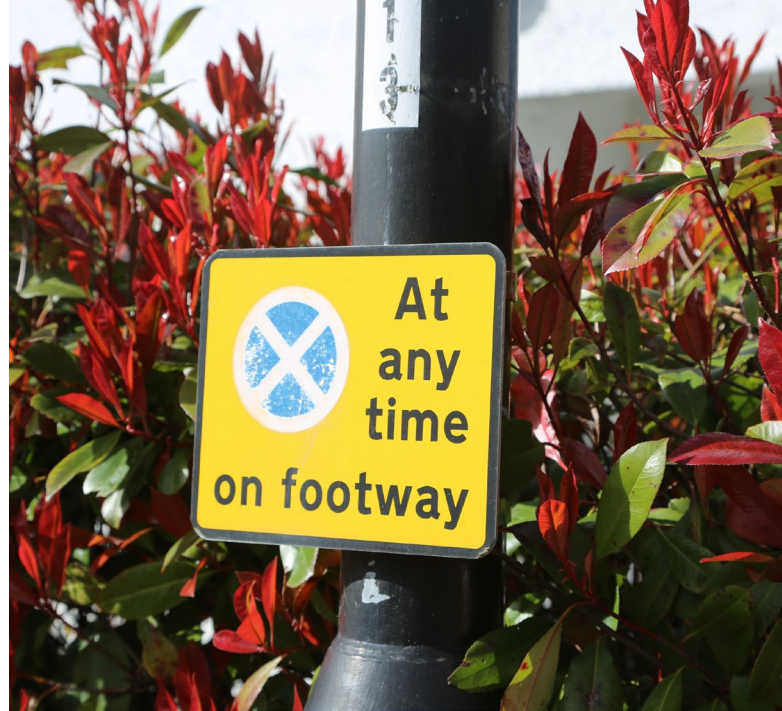
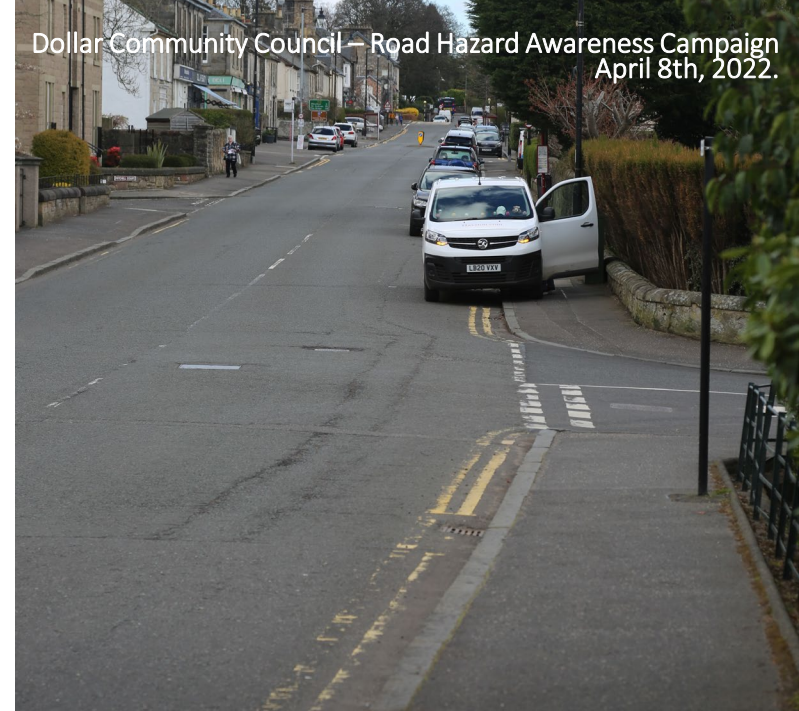
And some road signs are just too easy to ignore.

In the top picture drivers turning into Devon Road are forced to swing out wider than is sensible.

In the second photo, traffic accelerating through the 20mph to 30mph transition end up diving into the middle of the road in conflict with oncoming vehicles doing the same from the opposite direction.

In both cases pedestrians are forced off the pavement and into the roadway.

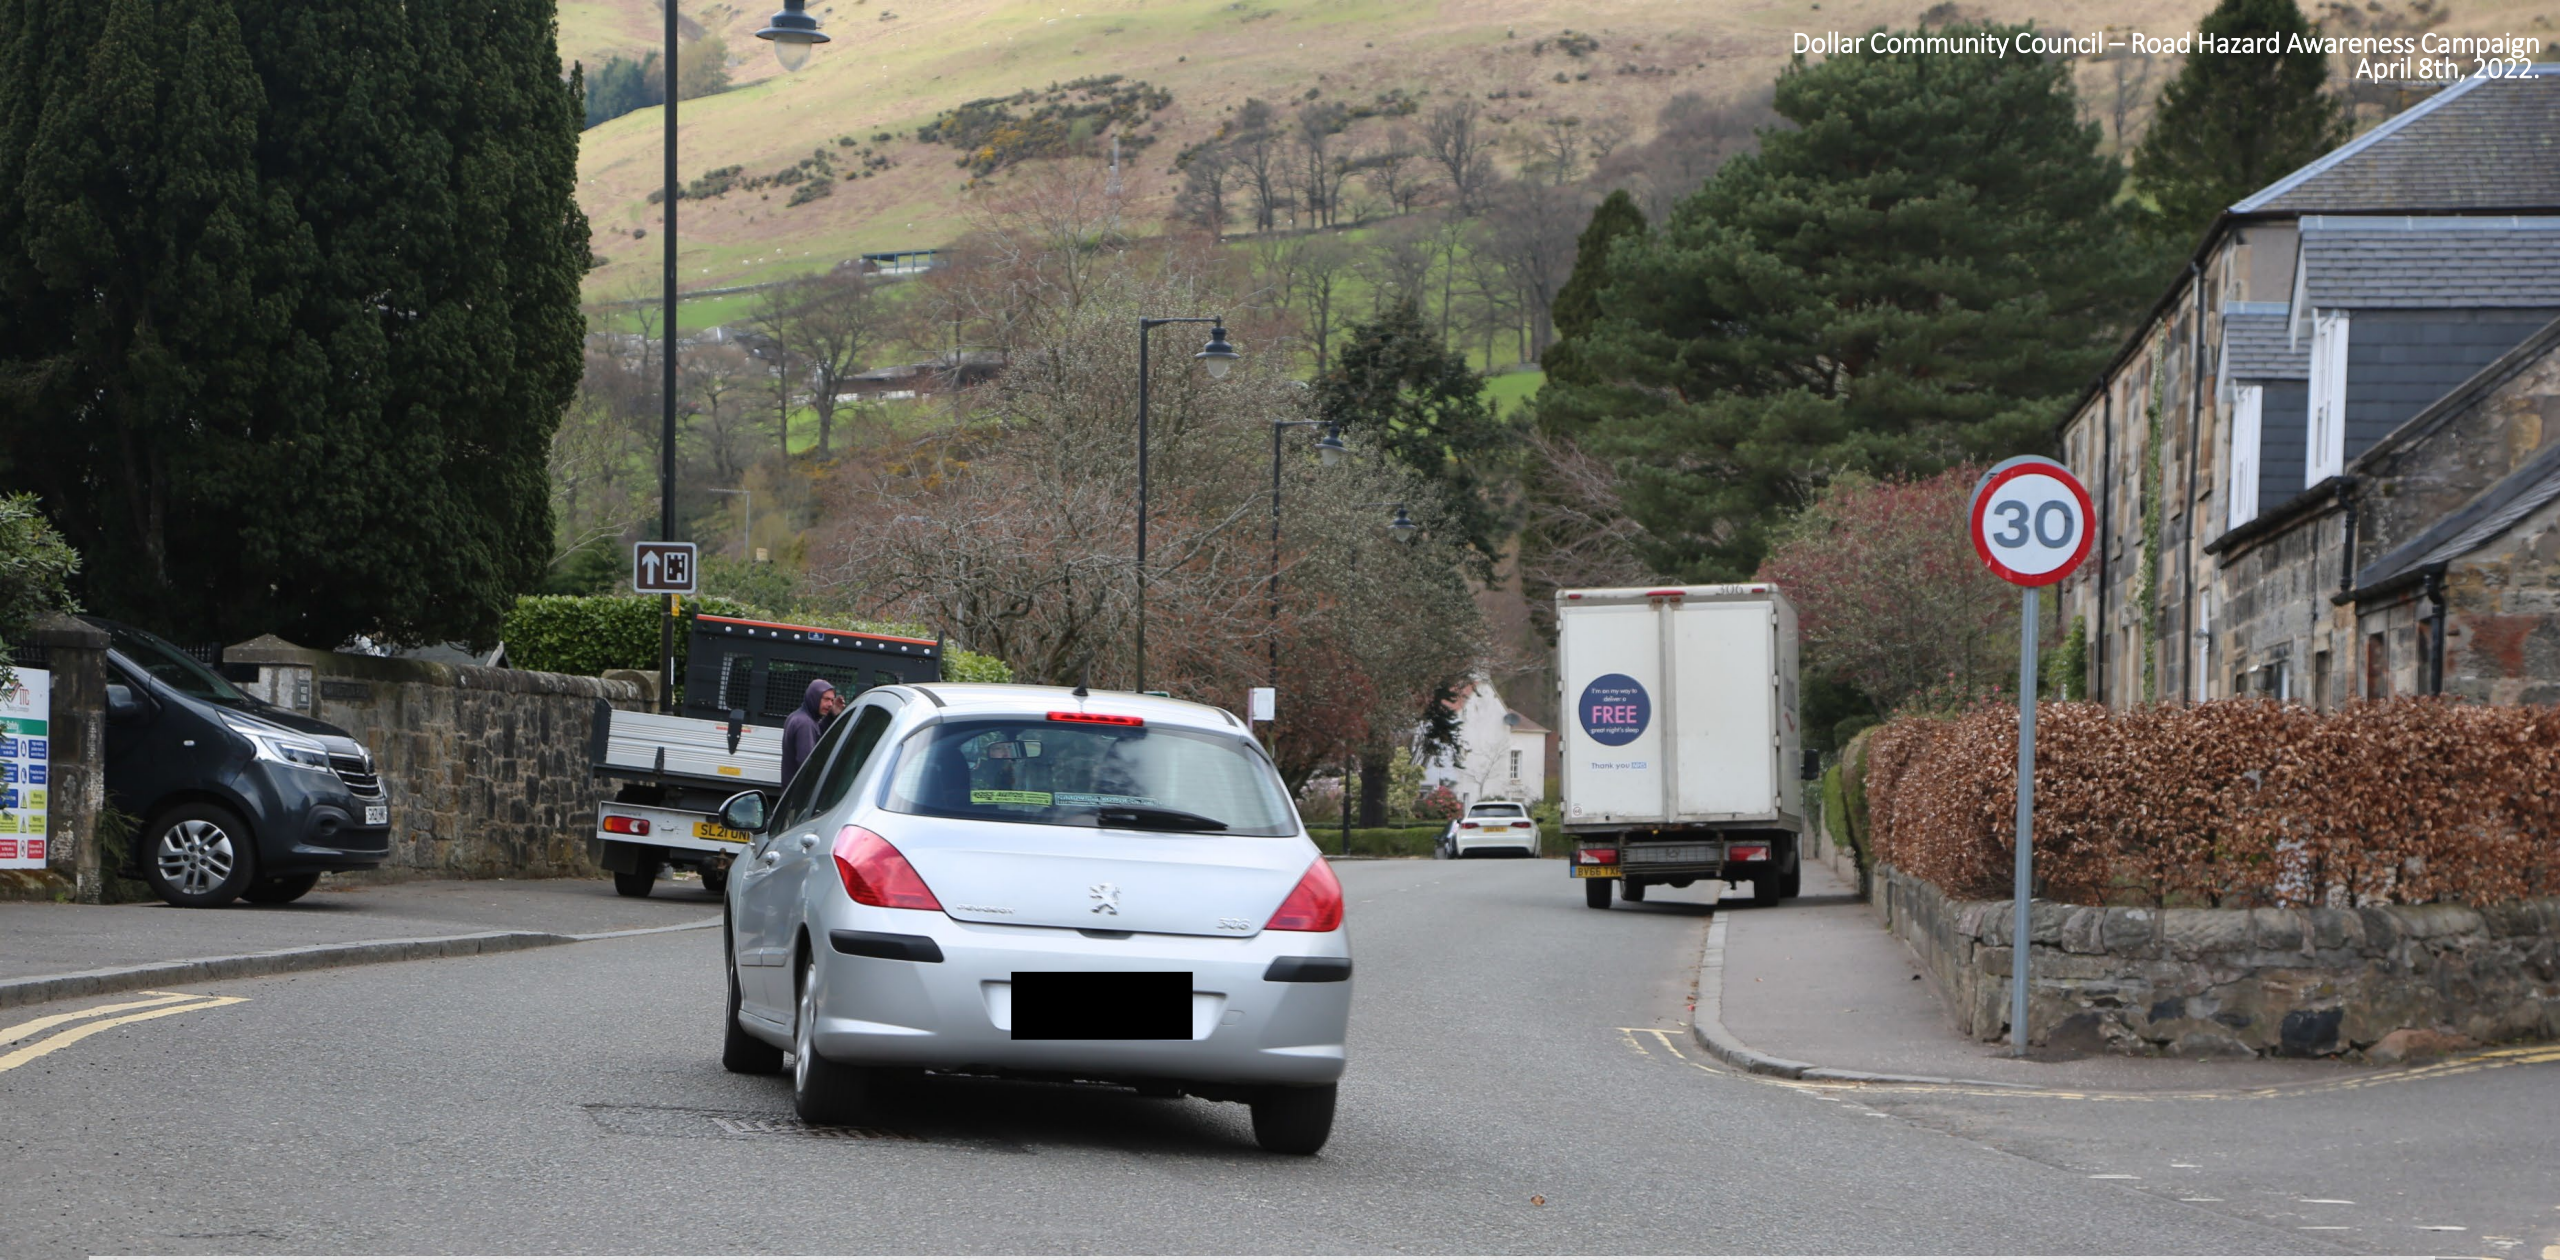
Would this driver have stuck to their own side of the road if road markings were properly maintained? And still travelling at 20mph instead of accelerating to over 30mph?

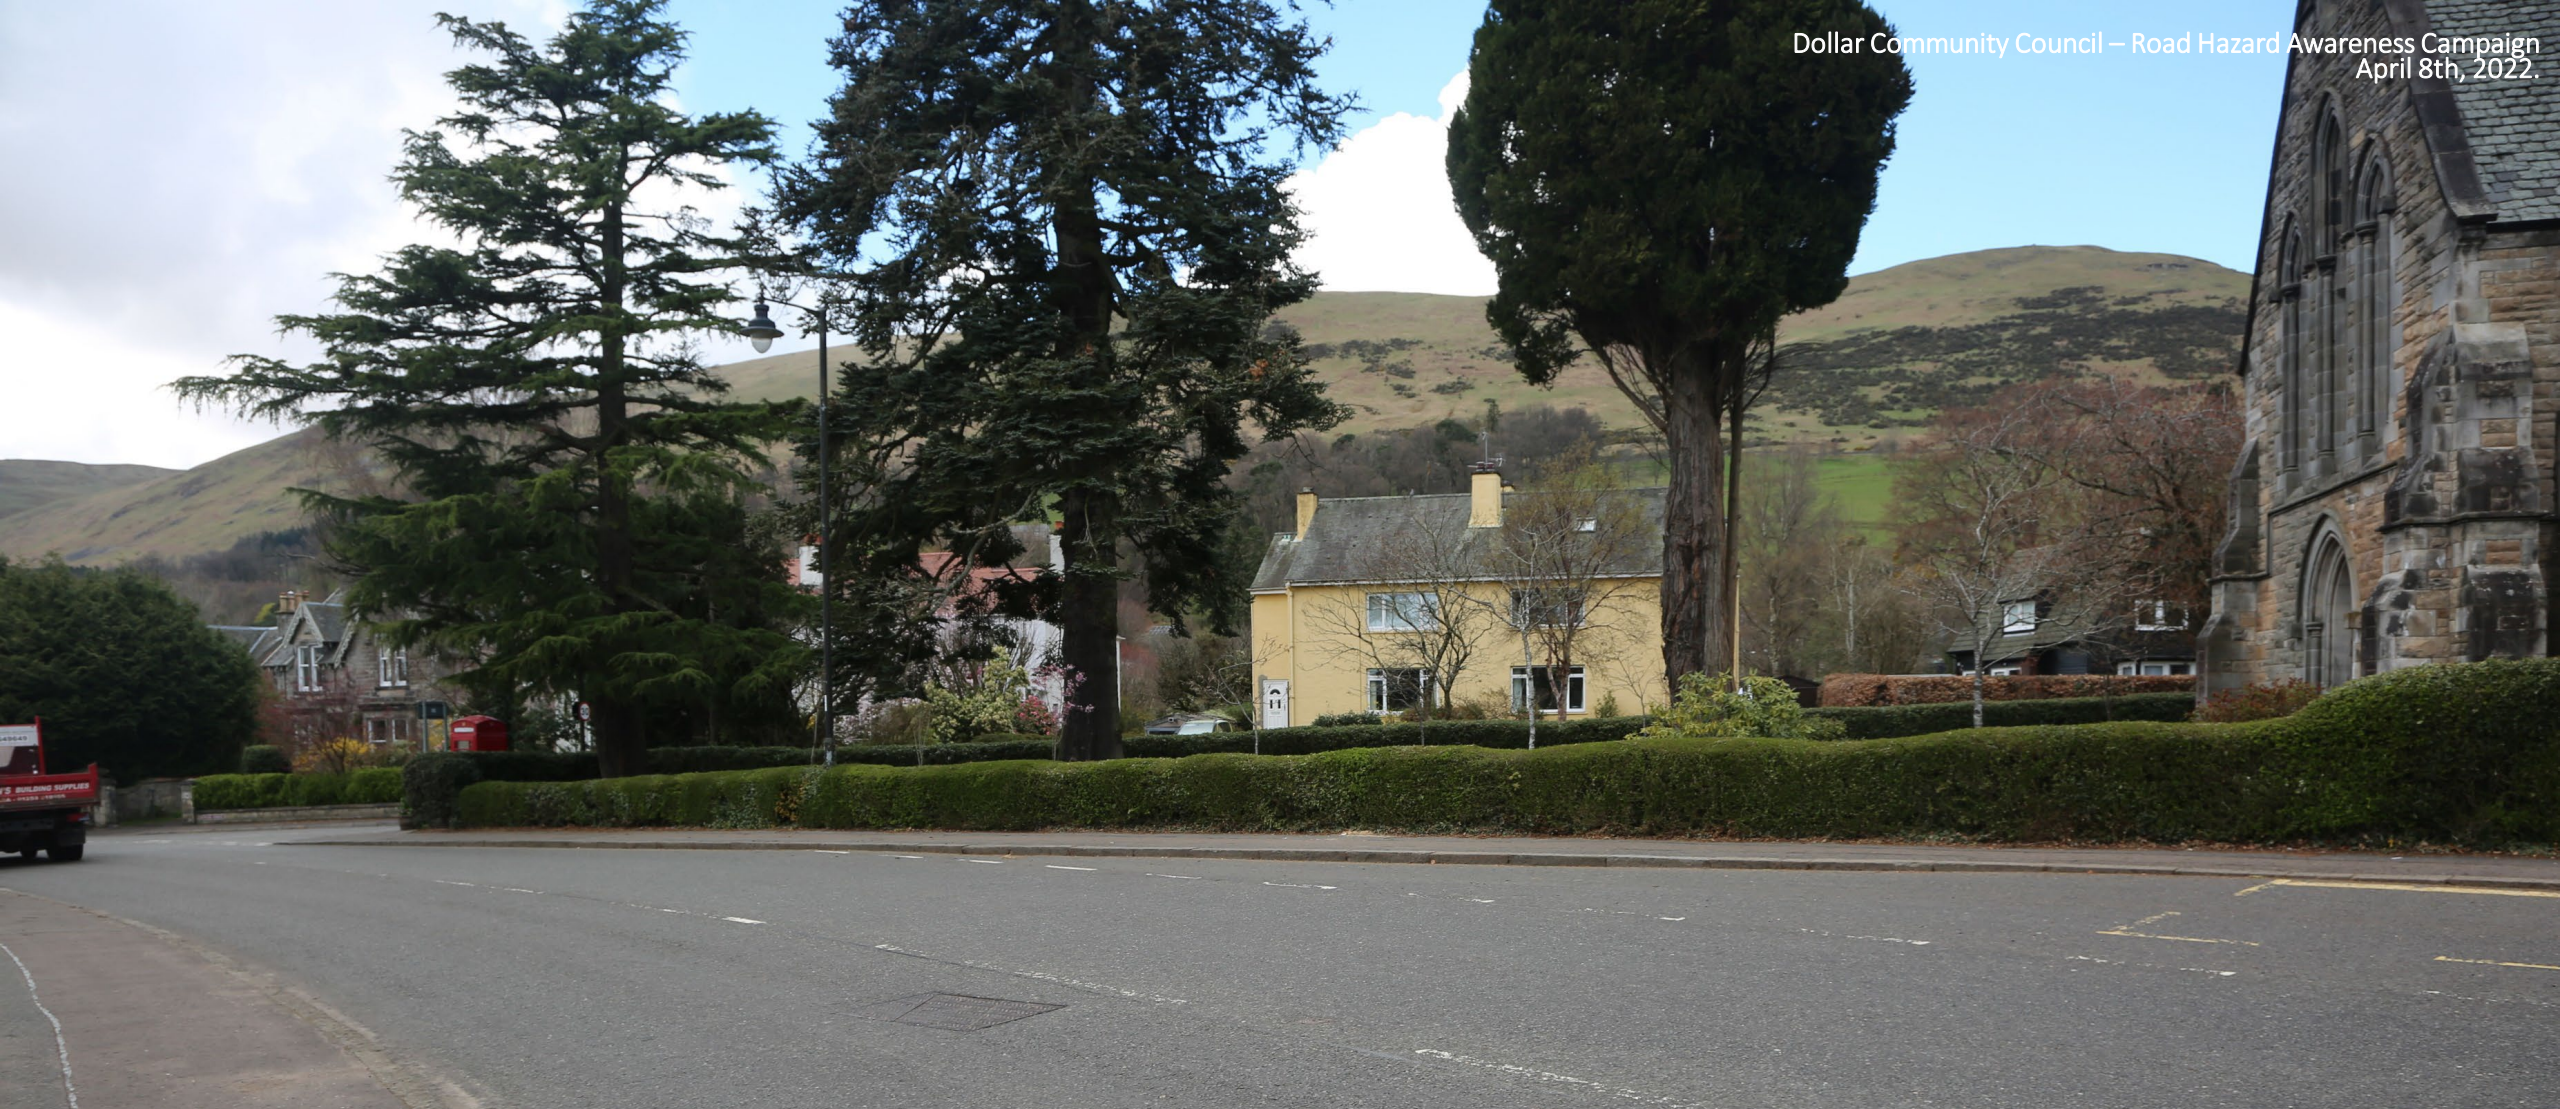
It would be worth considering introducing some form of pedestrian island at this wide section of Bridge Street which often sees elderly and vulnerable local citizens attempt to cross the road with no island in the middle and traffic failing to observe the speed limit. It is simply a question of time before a serious RTA takes place at this location.

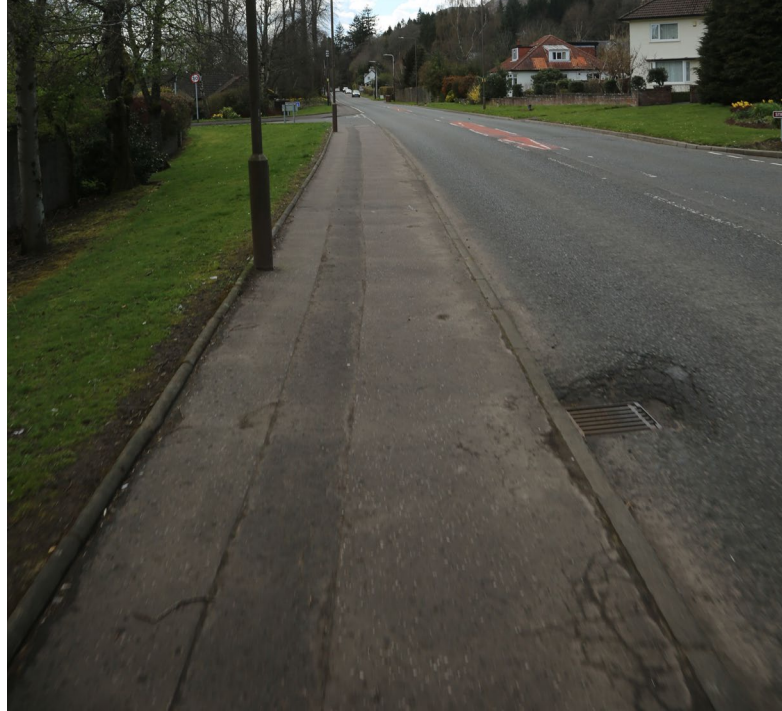
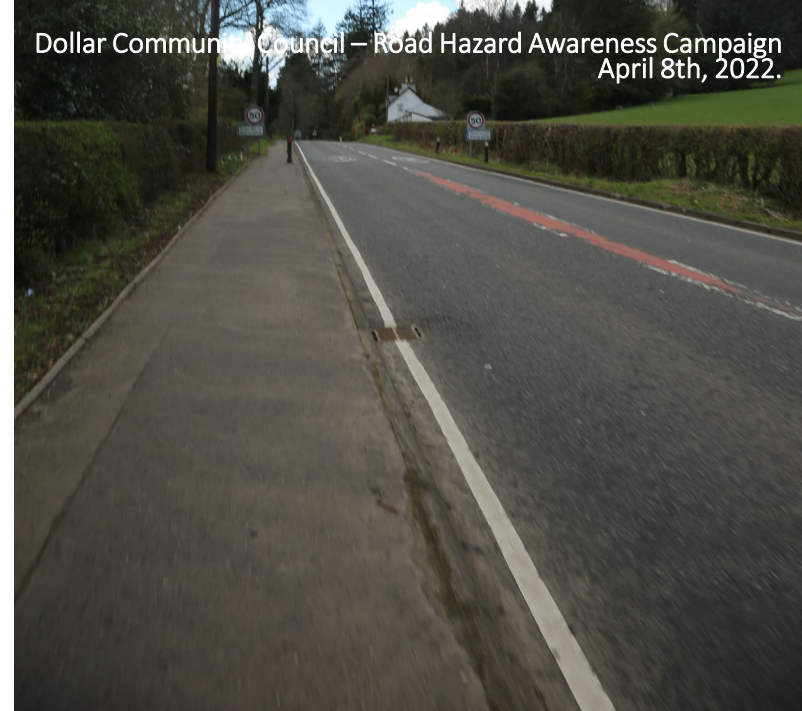
Even where traffic “islands” have been created to assist pedestrians to cross the road in relative safety, the road markings are so indistinct as to be easily ignored by impatient drivers who often rush to accelerate past slower moving traffic on Bridge St. A91.

Consideration has to be given to a better “refuge” area in the middle of the roadway.

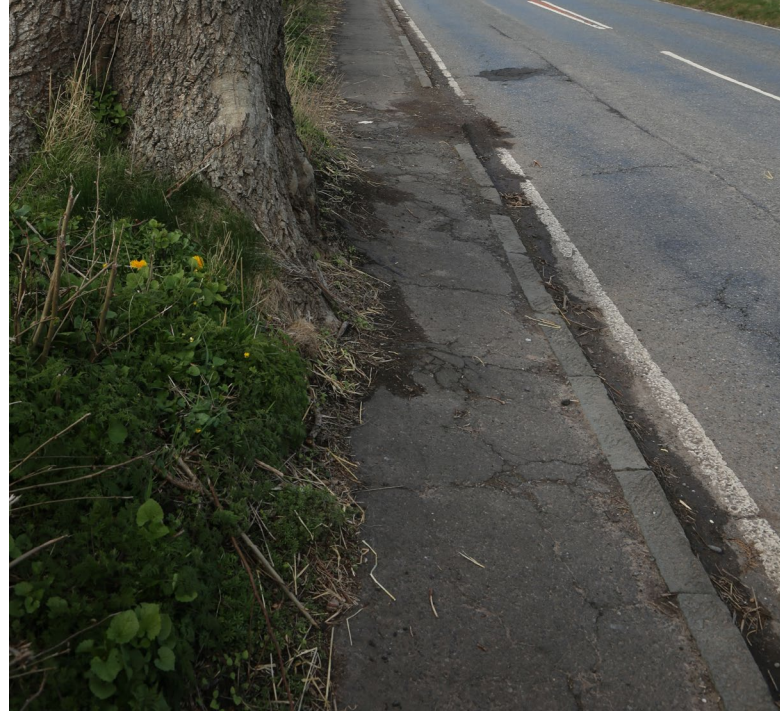
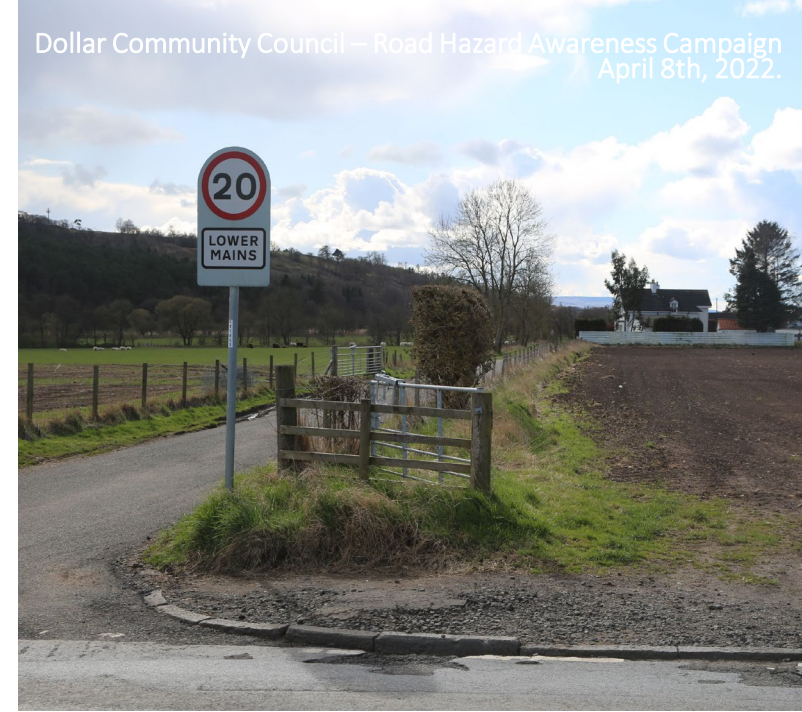
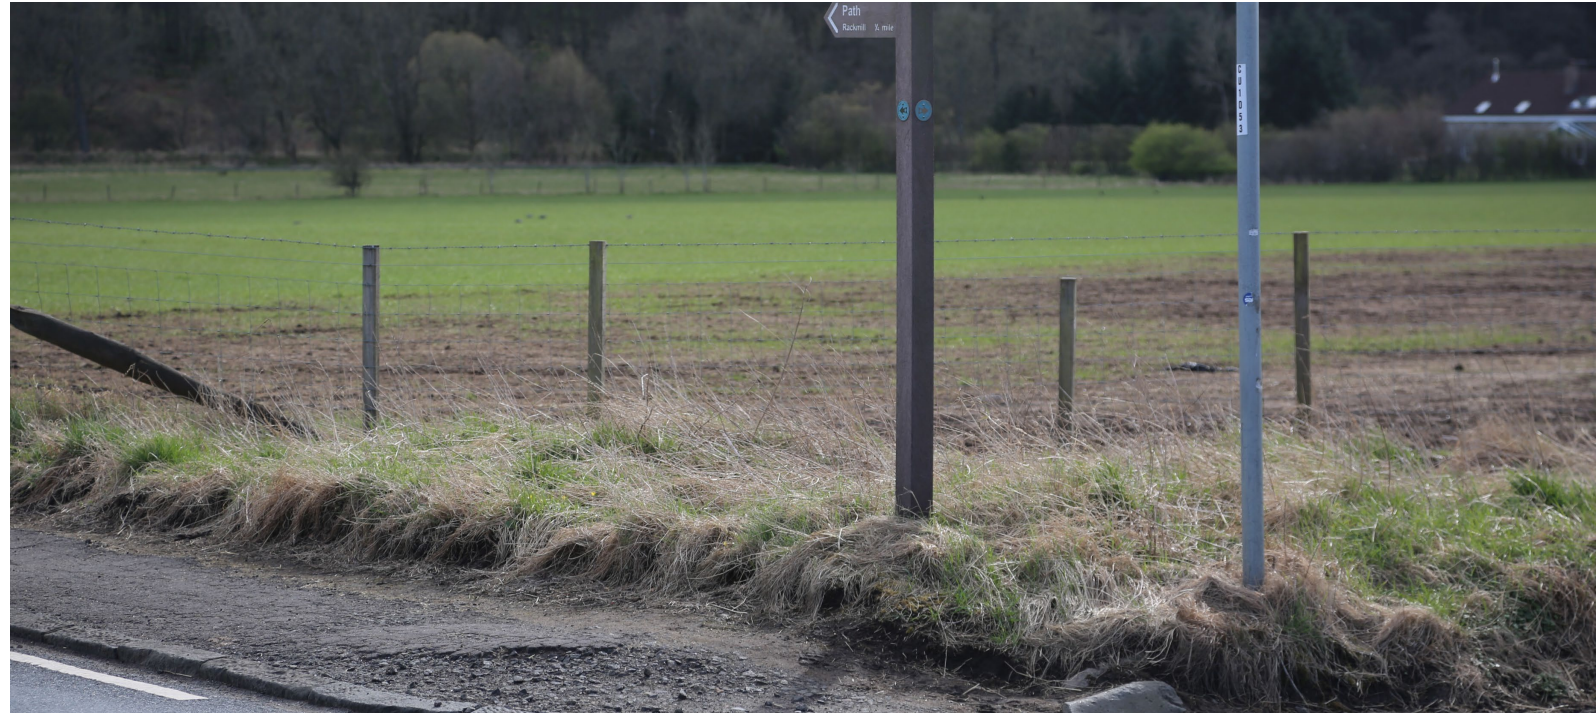
These three images at Lower Mains illustrate the broken and damaged surface of the pavement caused by agricultural traffic and drivers cutting the corner turning left off the Devon Road.

It needs repair to prevent forcing pedestrians into the roadway.
