Dollar Community Council – Road Hazard Awareness Campaign
April 8th, 2022.

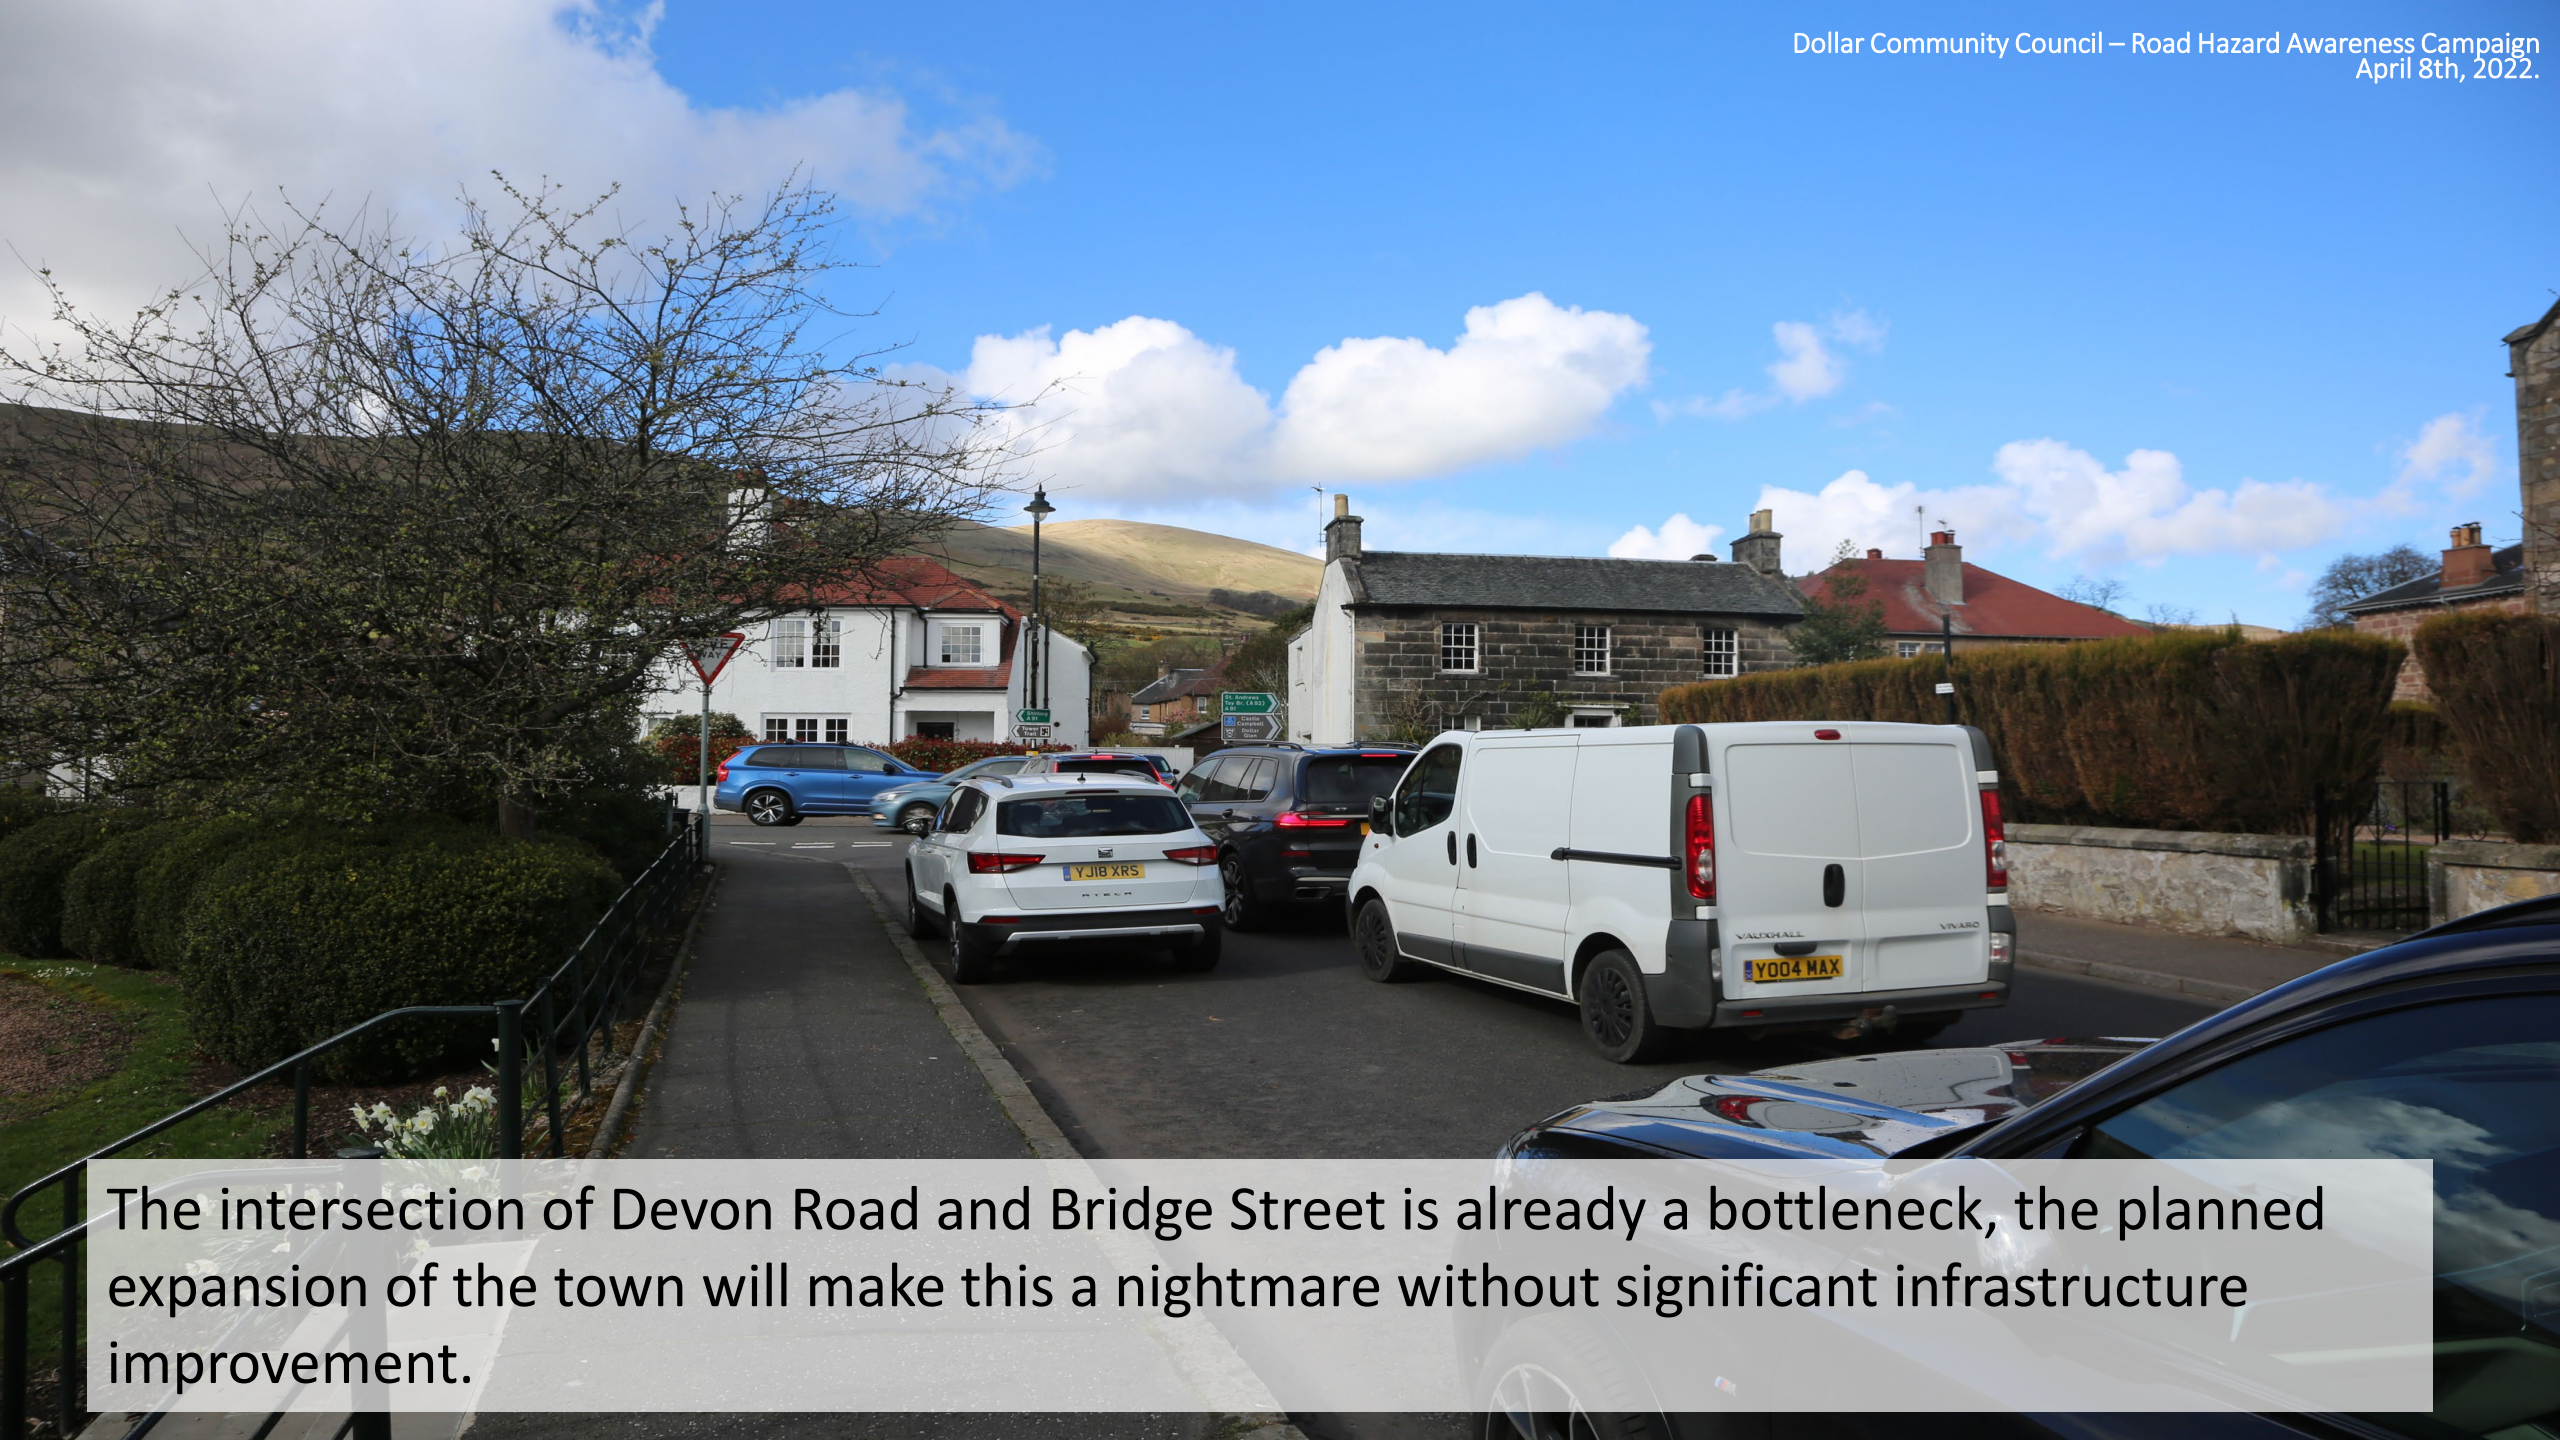
The intersection of Devon Road and Bridge Street is already a bottleneck, the planned expansion of the town will make this a nightmare without significant infrastructure improvement.
