Dollar Community Council – Road Hazard Awareness Campaign
April 8th, 2022.

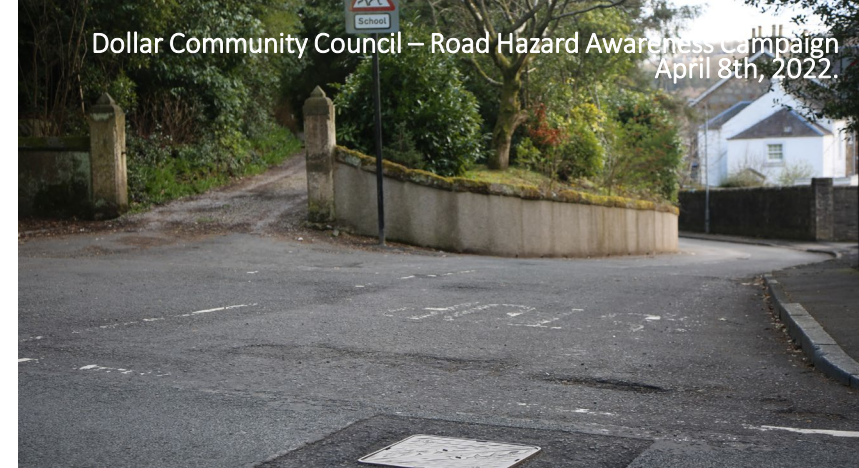
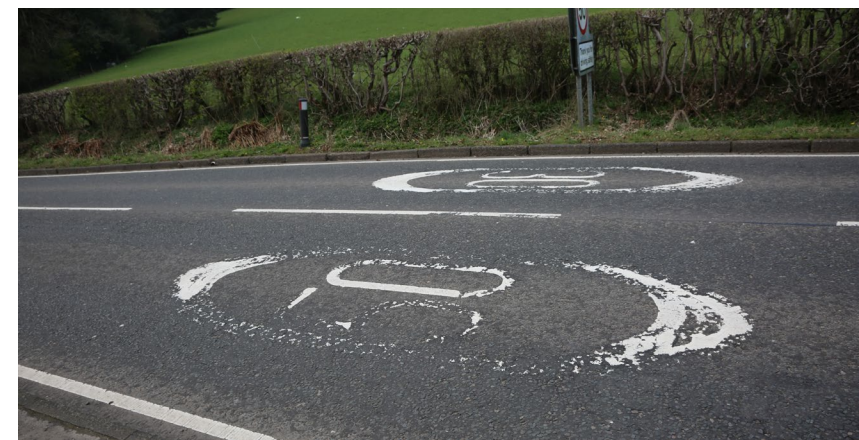
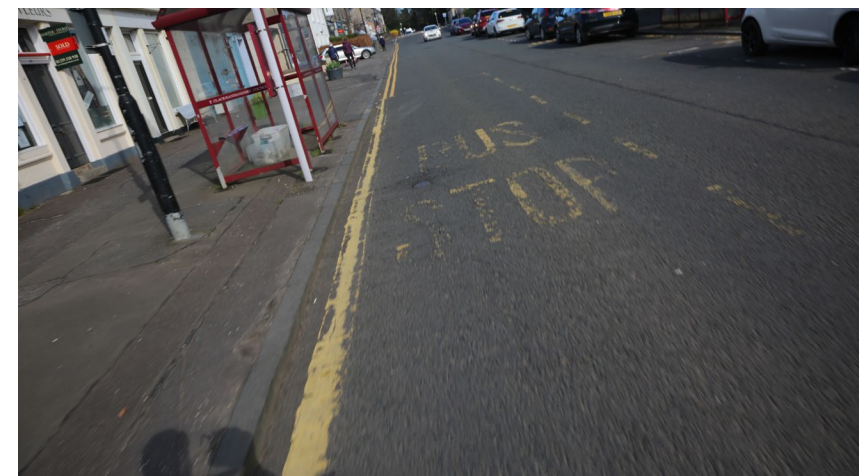
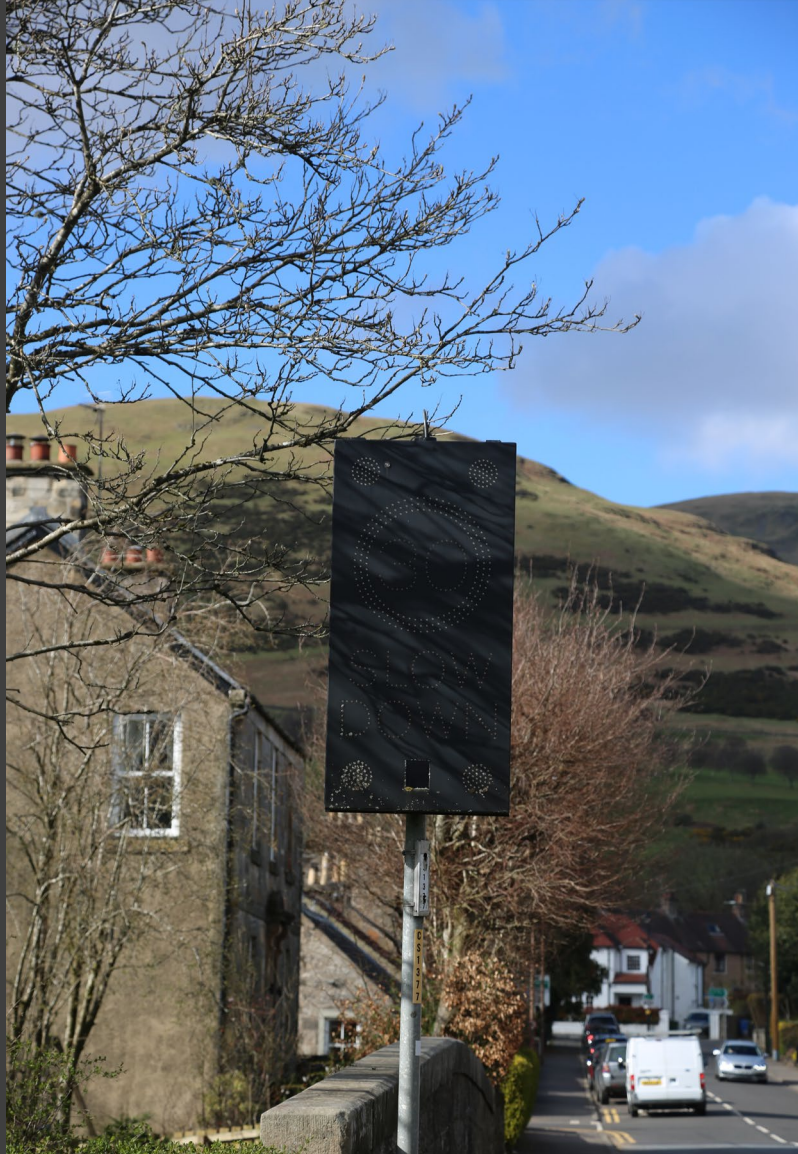
Throughout the town, in critical locations road markings are faded and eroded, failing to alert road users to the hazards.

- (1) eroded central line markings on Bridge Street do not guide vehicles to stay to their own side of the road.
- (2) this Stop junction road markings are virtually illegible – Kellyburn and Lover’s Loan both have similar damage to the road markings.
- (3) the speed limit signs on the A91 at the Tillicoultry side of town are badly faded and in wet conditions barely legible.
- (4) This Bus Stop in the middle of the town is barely readable.

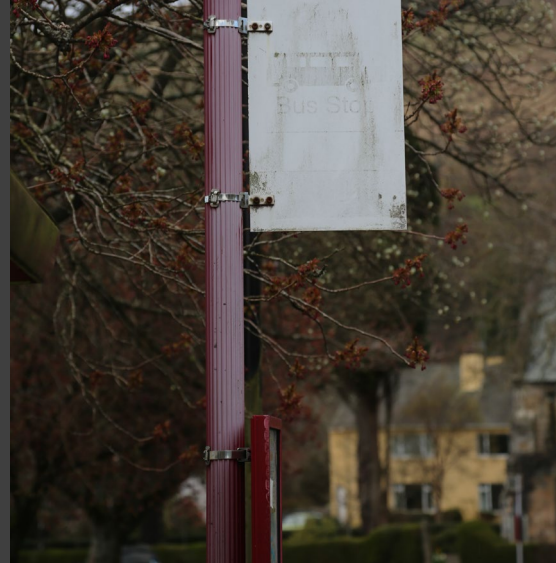
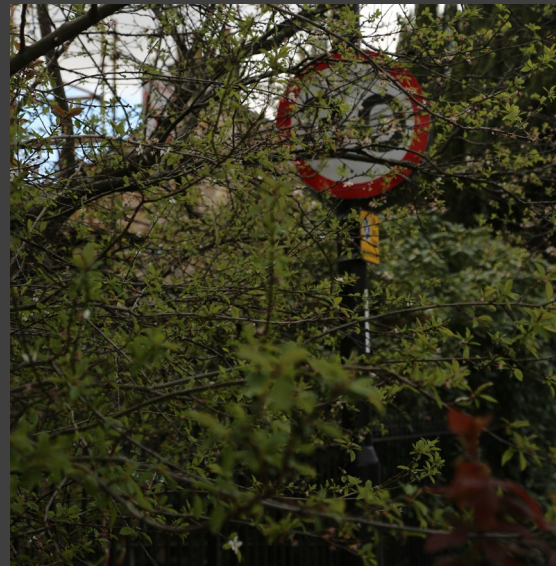
The dysfunctional Interactive Speed warning sign on the Devon Road approach to Dollar is another example of road furniture not working adequately to communicate with motorists and vehicle drivers.

The faded Bus Stop sign and obscured speed limit road sign mean that motorists are not properly and adequately alerted to danger zones throughout the town.

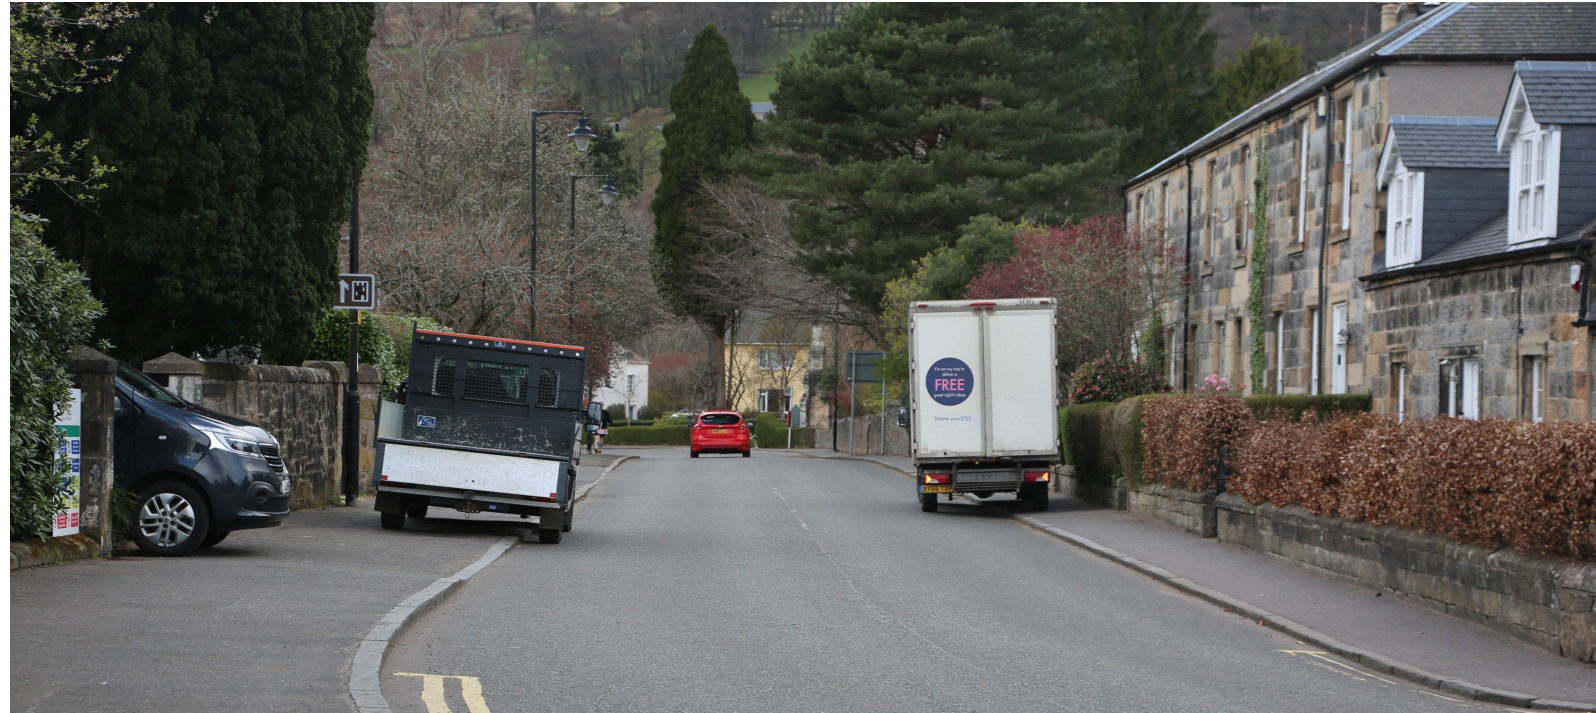
Would this driver have stuck to their own side of the road if road markings were properly maintained? And still travelling at 20mph instead of accelerating to over 30mph?
